CRASH INJURY EVALUATION

AC-1 DE HAVILLAND CARIBOU

U. S. ARMY AC-1 DE HAVILLAND "CARIBOU" EVALUATION
Ft. Rucker, Alabama
21 January 1960

REPORT OF CRASH INJURY EVALUATION
A/CIR-14-PV-121
October 1960

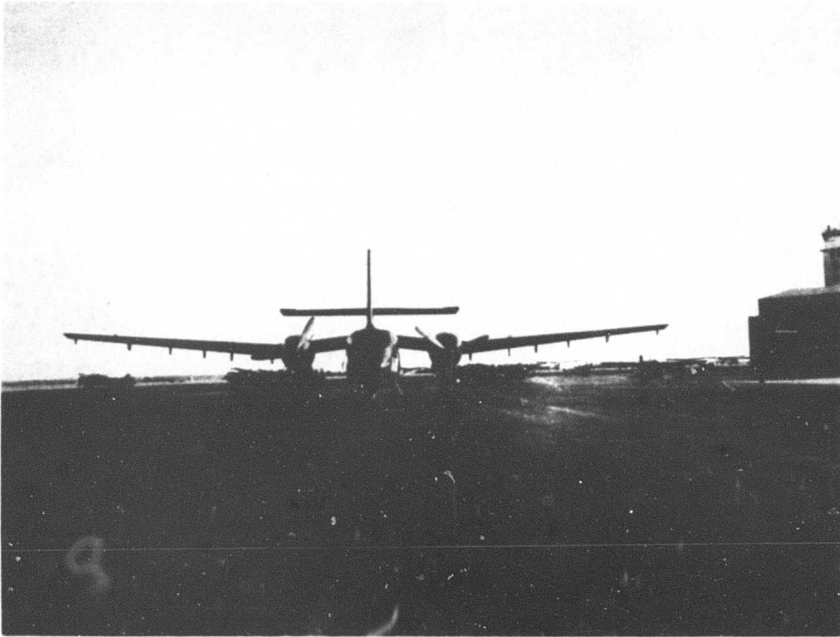
Although some of the floor members are designed to serve as longitudinal skids in the event of a belly landing, caution should be used when executing a wheels-up landing as a result of landing gear malfunction. In this type landing the fuselage structure must support more than half the gross aircraft weight (wing-engines-landing gear-fuel) which may result in excessive loads during unflared-landing crashes. *

Figure 4. Front view of Caribou.

Therefore, a flat terrain should be selected and the aircraft should be flown in rather than dropped in to prevent crushing of the cabin compartment by the heavy super-structure.

1. If conditions permit, crash landings be made with the landing gear extended, regardless of the terrain used.
2. If landing gear malfunction dictates a wheels-up landing, flat terrain be selected and the landing technique be aimed at minimum vertical load at touchdown.

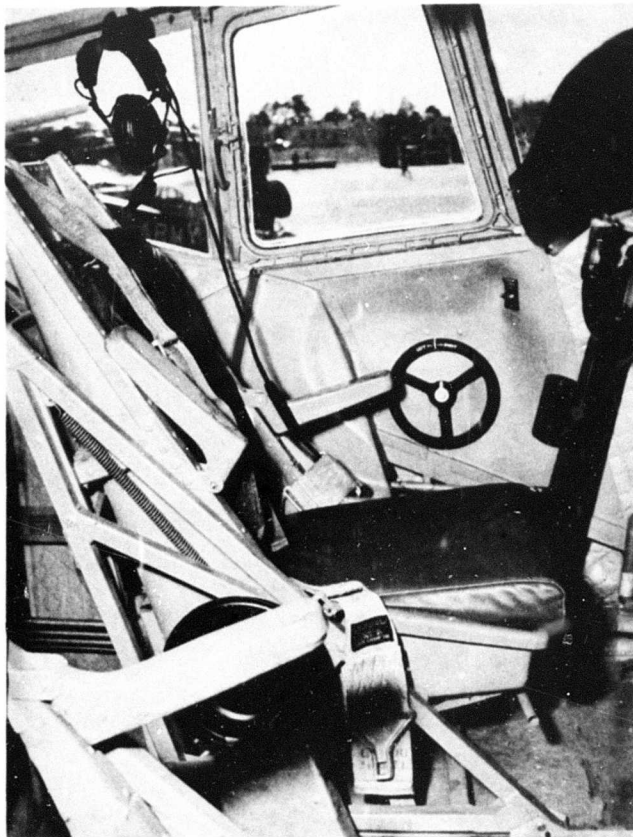
Figure 5. Pilot's seat.

The pilot's and copilot's seats in this aircraft are attached to floor tracks in a side-by-side arrangement. The seats are adjustable in the fore and aft direction by means of a frame which slides over two floor tracks. They are vertically adjustable in this frame by means of levers and springs (Figure 5). The seats are equipped with seat belt (type MD-2), shoulder harness (type MB-2), and inertia reel (type MA-1), all attached to the seat. This arrangement is not desirable from the crash safety point of view since the occupant restraint effectiveness depends upon the seat tie-down strength.

Attachment of the seat belt and shoulder harness to basic aircraft structure would relieve the seat of much of the crash load during crash deceleration and offer some form of occupant protection even when the seat tie-down failed. On the other hand, it is realized that this would entail certain inconveniences for the occupant because vertical seat adjustment would always necessitate seat belt adjustment while shoulder harness adjustment might be necessary before or after vertical and/or horizontal seat adjustment. Based upon this analysis, it appears advisable to have the seat belt attached to the seat as presently attached.

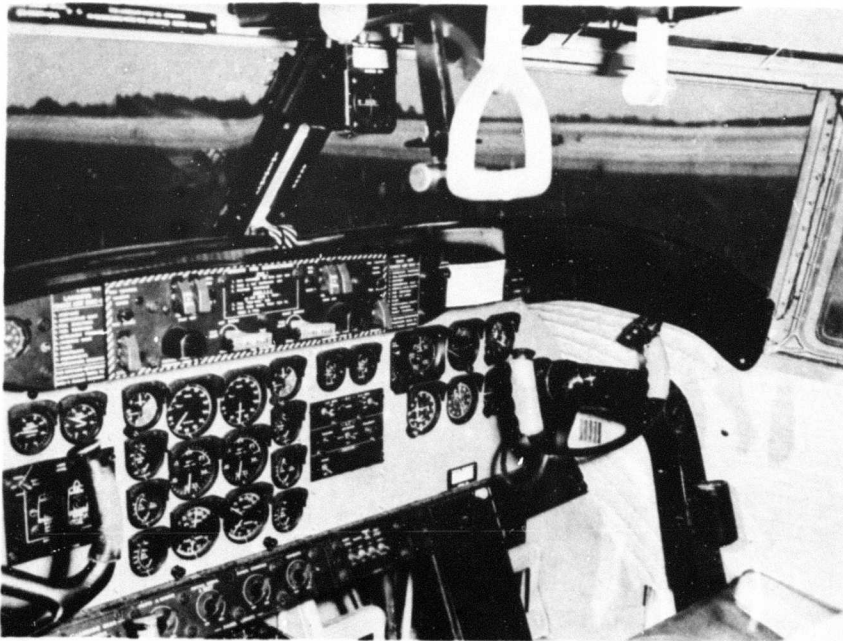
The cockpit gives an "uncluttered" impression which is mainly due to the overhead location of the engine controls (eliminating the conventional control pedestal) and the stowable radio equipment which is located on a console between the crew seats and slides forward into the instrument panel (Figures 6 and 7).

Figure 6. Right side of the cockpit, showing overhead location of engine controls.

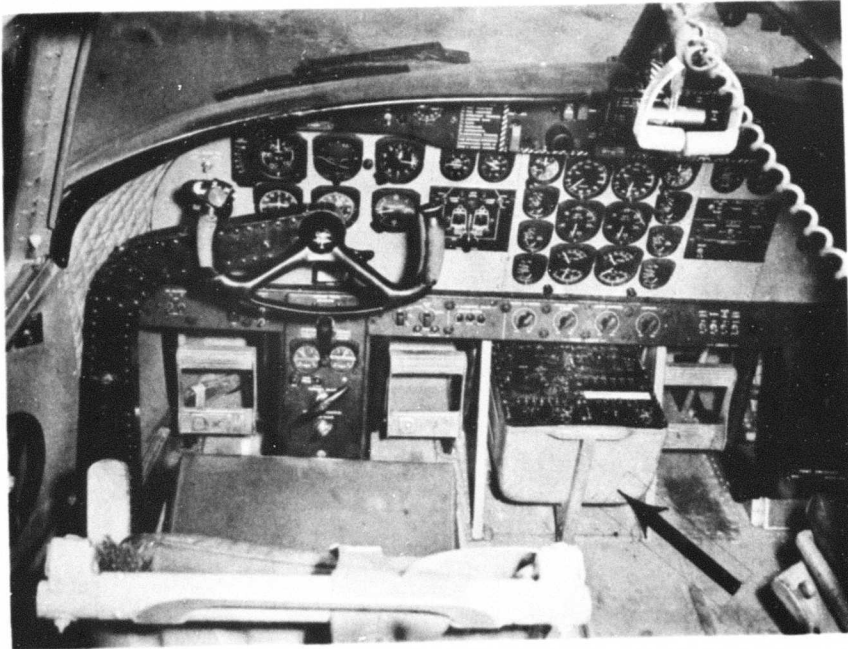
Although the tie-down strength of this console could not be accurately assessed, it can be stated that its resistance against abrupt decelerations should be at least equal to that of the crew seats to prevent it from becoming a dangerous projectile or imposing an additional load on the adjacent seat attachments.

Figure 7. Left side of the cockpit, showing the stowable radio console between the pilot's and copilot's rudder pedals (arrow).

1. The cockpit has several desirable features which reduce the number of objects within striking range of the crew.
2. The stowable radio console would constitute a serious hazard if it became dislodged.

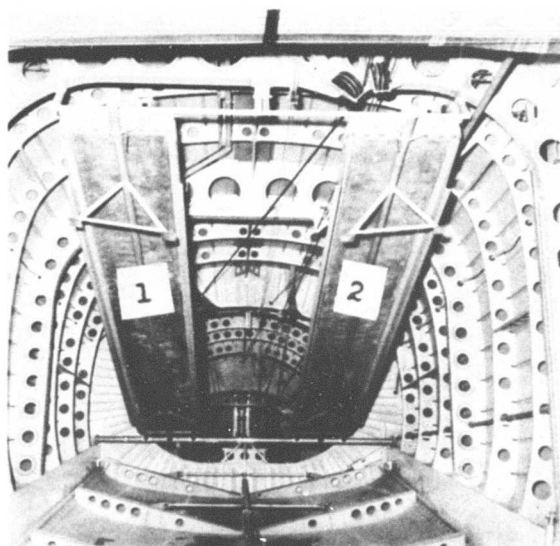
Two auxiliary ramps, to facilitate loading wheeled vehicles, are stowed against the ceiling in the aft fuselage above the cargo door (Figure 10). It is impossible to make an analysis of the tie-down strength of this installation based upon the available data. It can only be stated that these ramps would create a serious hazard for the cabin occupants if they became dislodged as a result of impact forces or distortion of the aft fuselage.

Figure 10. The two auxiliary ramps (1 and 2) are stowed against the ceiling in the aft fuselage above the cargo door.

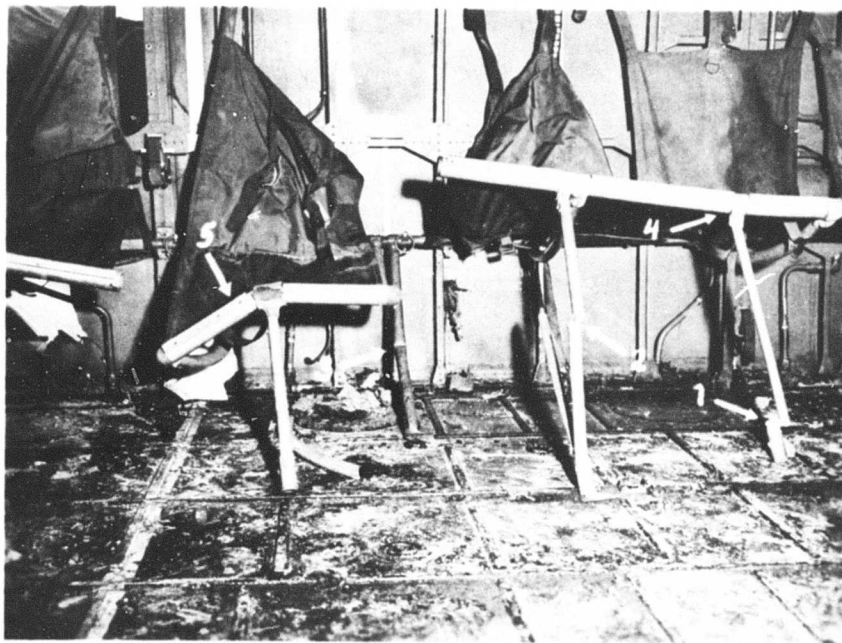
The effect of moderate crash forces on seats of similar design is shown in Figure 14. The seat legs and the front support tube failed in a manner that exposed the occupants to serious injury.

Figure 14. Post-crash appearance of seats built in accordance with the same Military Specifications, installed in another aircraft, after a moderate impact. The arrows indicate failures.

5. The design requirements for troop seats as specified in MIL-S-5804B and MIL-S-27174 offer the occupants inadequate crash protection, particularly when the seats are subject to side loads. Past accident experience underlines this deficiency.

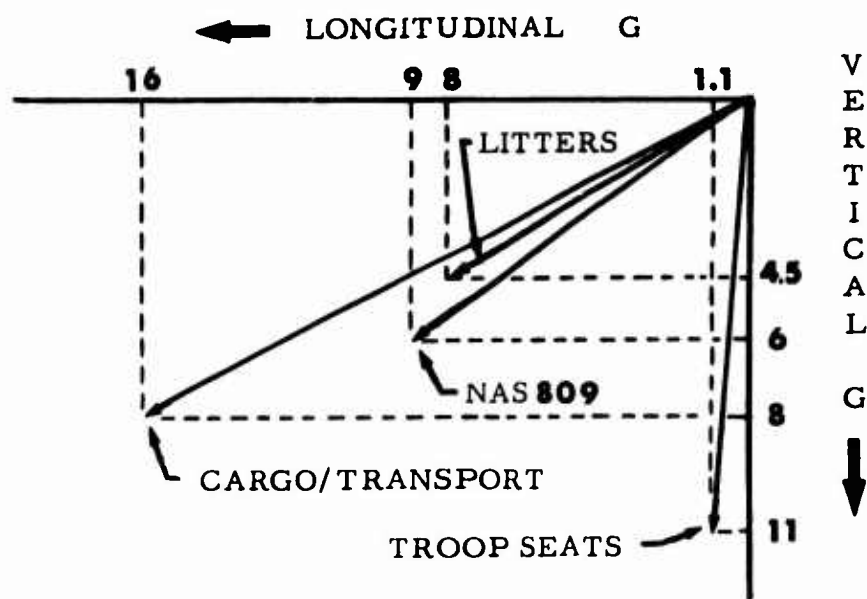
By making the favorable assumption that the static loads, which these structures must be able to withstand when applied separately, can also be sustained without failure when applied simultaneously, a more realistic approach to actual seat strength can be made. (See Figure 15.)

Figure 15. Static ultimate load requirements for seats, structures, and litters.

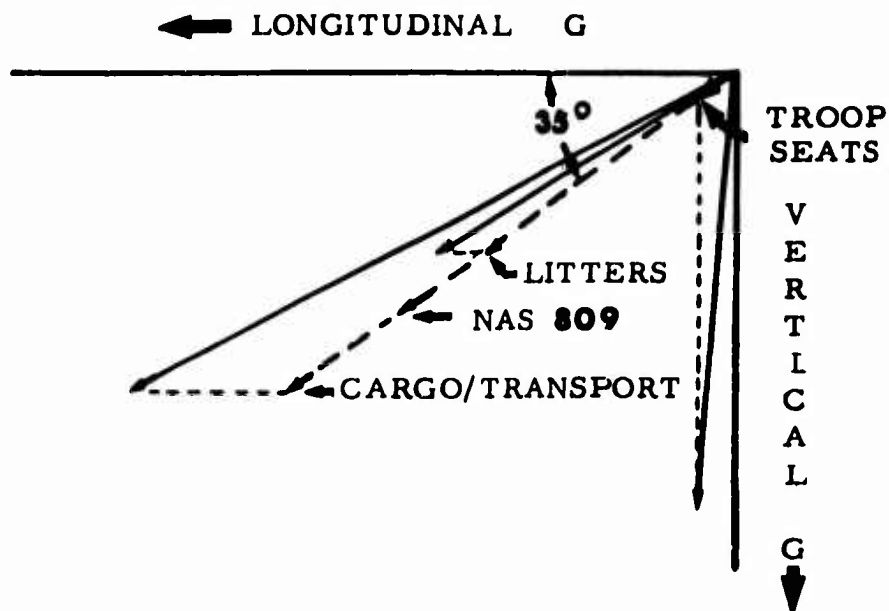
Figure 16. Ultimate load characteristics for seats, structures, and litters at 35° crash force angle.

The resultant ultimate load characteristics of cargo/transport structure, litters, and troop seats have been transposed to a 35° vector, which coincides with the resultant of the NAS 809 passenger seat requirements. This angle was chosen because accident experience seems to indicate that this is an acceptable mathematical average of the directions of crash force application in survivable accidents. The results of this transposition can be summarized as follows: At a crash force angle of 35° the theoretical ultimate load strength of the subject structures is shown in Table 4.

Table 4 indicates clearly that the crash resistance of the troop seats under anticipated survivable impact conditions is inadequate.

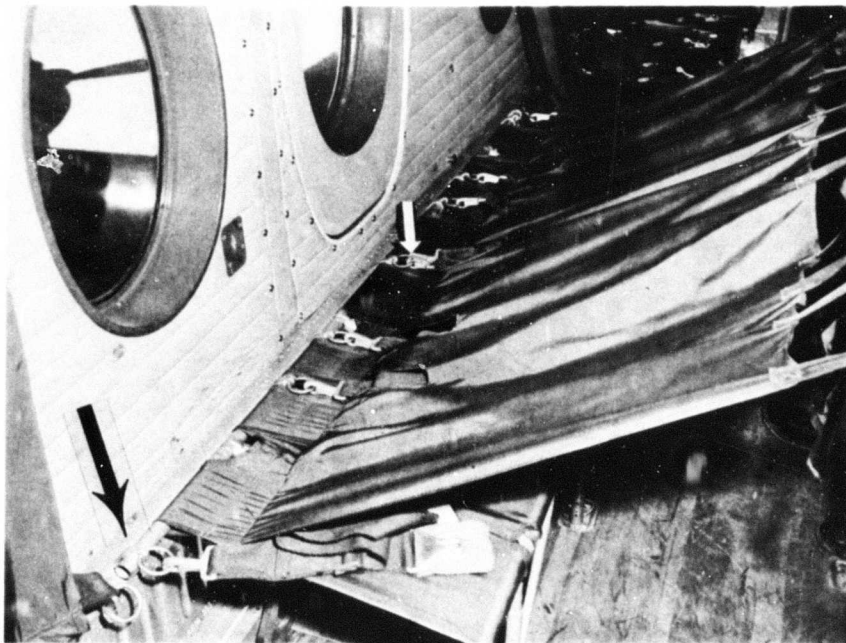
The manner in which the seat belts in the Caribou are anchored to basic structure (Figure 17) shows improvement over the anchorages observed in previously evaluated aircraft. The system of the "D" ring and the drilled hole in the rear support tube, which frequently led to failure at these points as indicated by accident experience, is replaced by a clamp around the support tube. At one end this clamp is attached to the basic aircraft structure and at the other end there is a ring for seat belt anchorage.

Figure 17. The seat belts in the Caribou are directly attached to the clamps that secure the rear support tube to the basic aircraft structure (black arrow).

3. The seat belt anchorages in the cabin/cargo compartment show improvement over previously examined installations.
4. The ultimate load requirement of 11 G for the troop seat lap belt (MIL-S-5705) is inadequate. This has occasionally led to belt failures during otherwise moderate impacts.

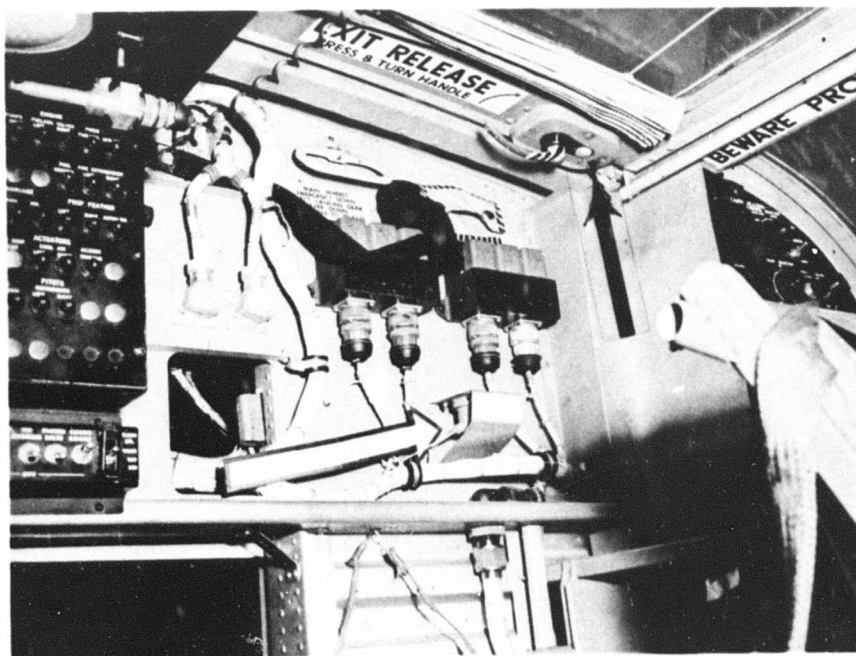
In addition to the bottom entry hatch, which can be jettisoned, there is an escape hatch in the cockpit structure above and behind the pilot's seat (Figure 19). The sliding windows on both sides of the cockpit provide alternate emergency exits. These arrangements plus the proximity of the cabin emergency exits to the flight crew area are adequate to permit rapid evacuation of the crew. To operate the top escape hatch a button must be pressed before the release handle can be turned. This button is rather small and flush with the surrounding surface. Quick manipulation of this button requires attention and accuracy. In conditions of darkness or crew incapacitation this could easily lead to delay in escape time.

Figure 19. Emergency exit release of the cockpit escape hatch above the pilot's seat. The black arrow indicates the button that has to be pressed before the handle can be turned. Notice that the instructions do not refer to the button.

Elimination of this button from the sequence of operation would facilitate operation and does not seem to constitute a hazard because the likelihood of inadvertent operation of this exit in the crew compartment by inexperienced personnel is practically non-existent.

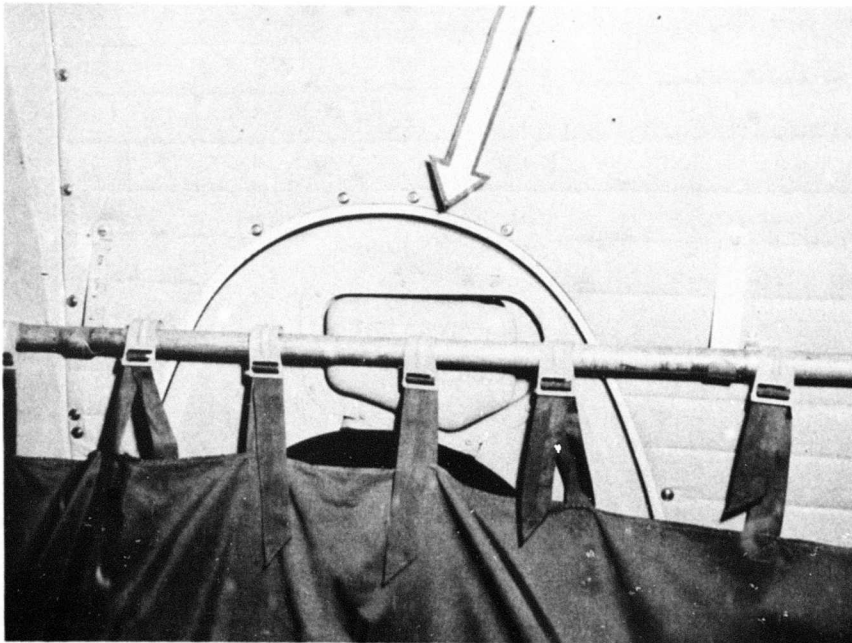
The cabin is equipped with an elliptical emergency exit located on the left side under the left wing. To operate this exit a handle must be turned which is covered by a guard. It will be noted in Figure 20 that this guard cannot be opened unless the upper seat back support tube has been removed. This tube also shields the emergency instructions on the guard. Since the greater part of the emergency exit is covered by the seat backs, it may go unnoticed by less experienced passengers.

Figure 20. To open the guard covering the exit release of the cabin emergency exit (big arrow), the upper seat support tube has to be removed. This tube also shields the instructions on the guard.

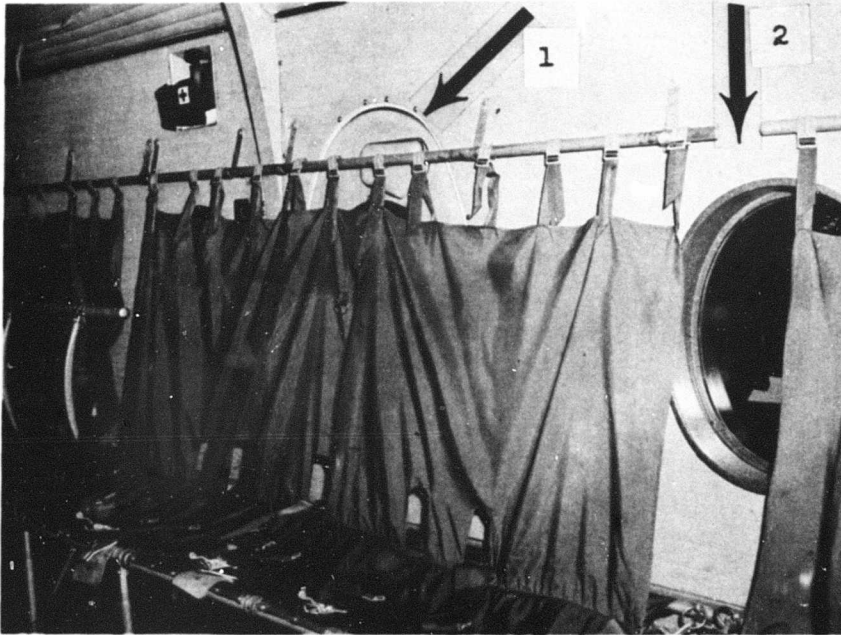
The effectiveness of this emergency exit and the ease of operation would be greatly increased if the open space between adjoining seats had been utilized (Figure 21). In addition, if the location of the exit release handle and guard were slightly changed (up or down) with respect to the upper seat support tube, this exit could be used without removal of seat structure.

Figure 21. The present emergency exit location in the cabin (arrow 1) necessitates removal of the upper seat structure before it can be used. Location of the exit between two adjoining seats (arrow 2) would simplify evacuation.

5. An extra emergency exit be added to the right cabin wall and that its location and design be governed by Recommendation 4.

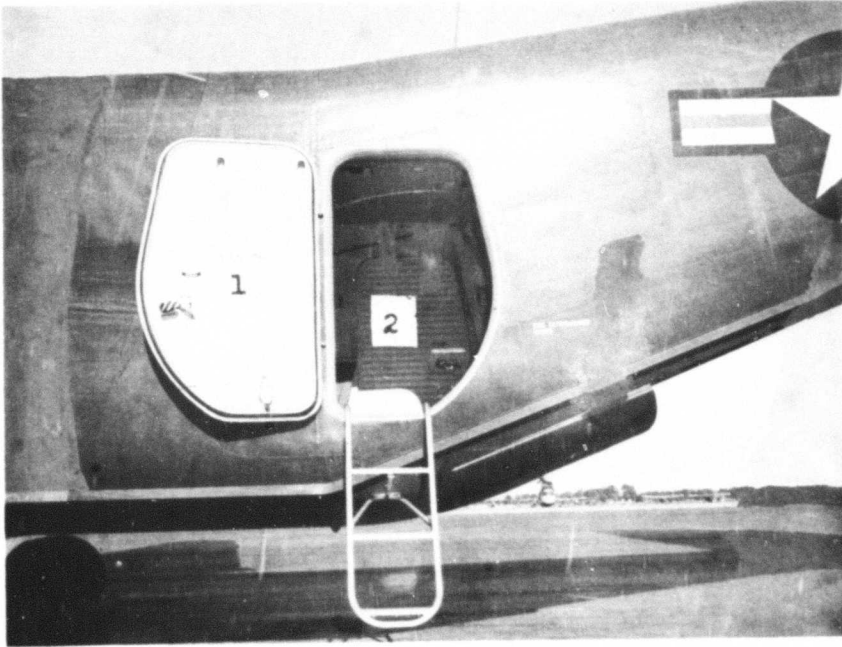
There are two doors (30 x 50 inches) on opposite sides at the aft end of the cabin (Figure 22). Although the one on the right is jettisonable according to the Model Specification, this was not the case in the model that was examined.

If the aircraft came to rest on its left side, two cabin exits might be rendered useless. This, in combination with possible jamming of the cargo door, would leave the cabin passengers with one exit only. The need for an extra emergency exit in the right cabin wall is also indicated in the following extract from the Handbook of Instructions for Aircraft Designers (HIAD - ARDCM 80-1):

Figure 22. The two doors on opposite sides at the aft end of the cabin (1 and 2) are not jettisonable.

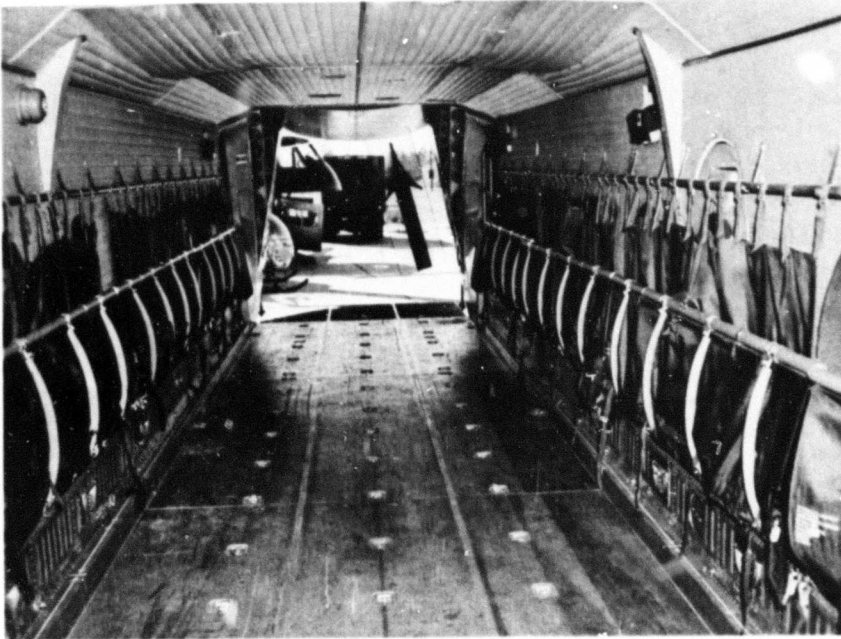
The rear cargo door provides a fourth emergency exit from the cabin compartment (Figure 23). The upper section of this door is jettisonable. The large size of this section and the manner in which it fits in the aft fuselage when in closed position make it very likely that this door will be jammed, when this part of the fuselage is distorted during a crash. Therefore, this door should not be depended upon as an emergency exit unless it is opened or jettisoned before impact. This further indicates the necessity of making both aft exits jettisonable.

Figure 23. The rear cargo door retracts in the roof structure of the aft fuselage (arrow). It can also be jettisoned.

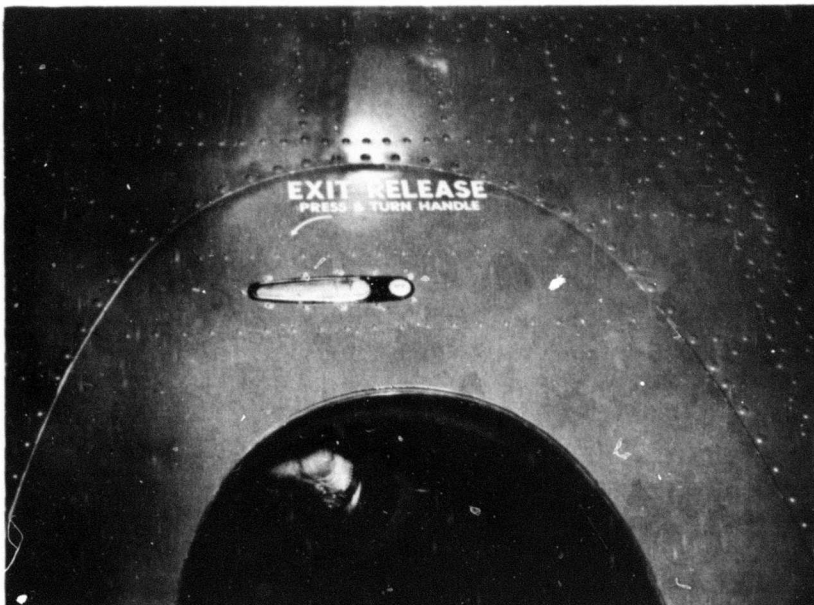
The instructions for the outside release of the emergency exit under the left wing are ambiguous. The instructions read: PRESS AND TURN HANDLE, while an arrow from the word "PRESS" points toward one side of the handle (Figure 24). Actually, the button that must be pressed first is located on the other side of the handle. Since this emergency exit release may be operated by inexperienced rescuers, thought should be given to less ambiguous instructions and a more direct way of operation.

Figure 24. The instructions for the external operation of the cabin emergency exit under the left wing are inadequate for inexperienced rescue personnel. The arrow under the word PRESS should point towards the button.

Although elimination of this button would increase the chance of inadvertent operation, this would not be a serious hazard since it can be done only while the aircraft is on the ground.
